An Archaeological Walkover Survey at Sutton Park NNR,  
Royal Sutton Coldfield, Birmingham, West Midlands.  
SP 08600 97200 (centre)

ULAS Report No. 2025-030  
© ULAS 2025

# **An Archaeological Ground Survey at Sutton Park NNR, Royal Sutton Coldfield, Birmingham, West Midlands**

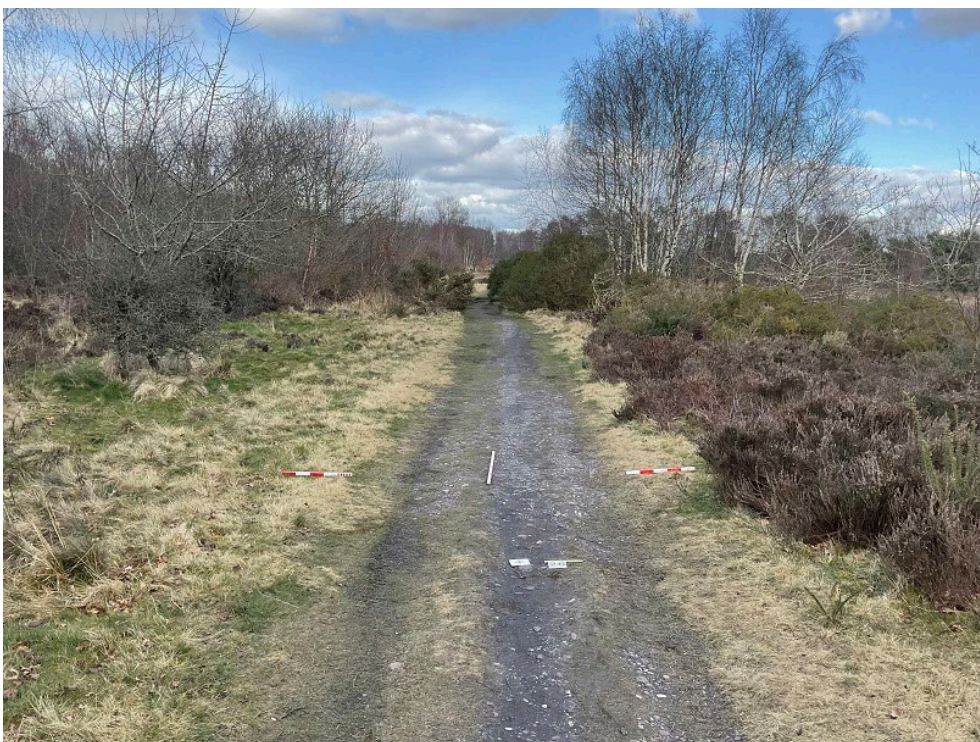
Figure 5: The agger within the peaty heathland, looking north (Photo 101, Feature Observation 26)

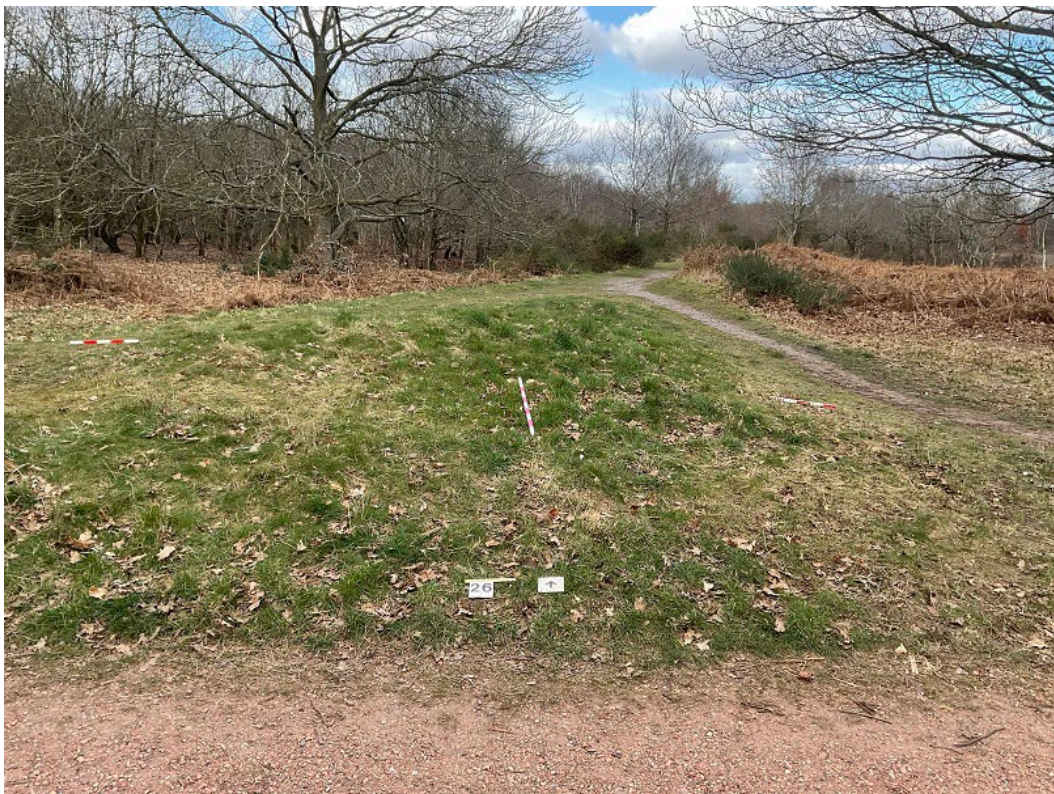
Figure 6: The agger at the northern end of a section of footpath near Royal Oak Gate, looking north (Photo 94, Feature Observation 26)

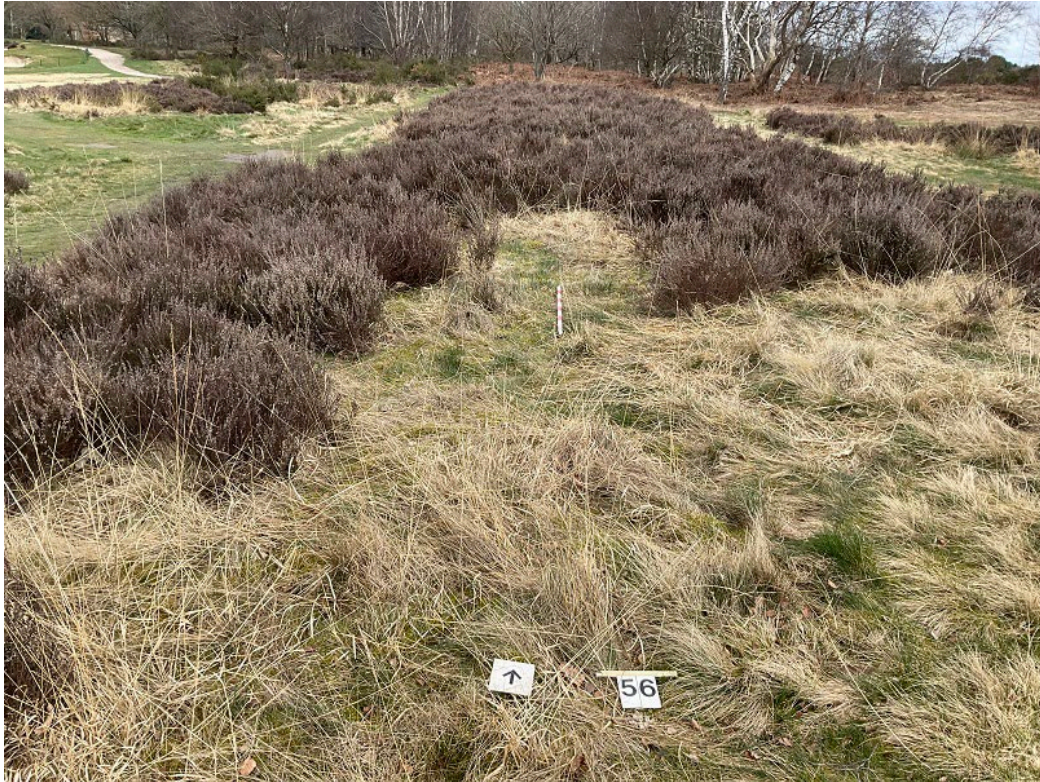
Figure 7: The agger within the heather to the south of the golf course, looking north (Photo 200, Feature Observation 56)

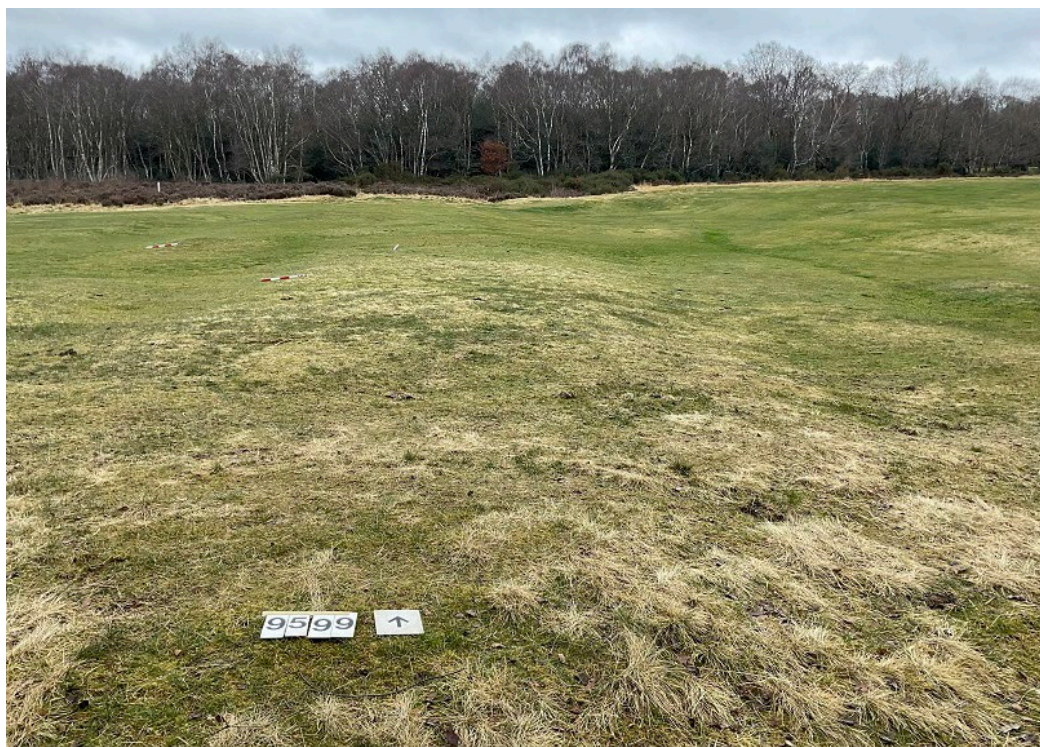
Figure 8: The agger as it crosses the golf course, looking north (Photo 327, Feature Observations 95, 99)

The agger of the road was usually fairly easy to identify, particularly across the heathland where it had been followed by the line of a footpath for much of its length. As it approached the golf course the line of the footpath deviated and the agger was discerned as a linear mound covered in bracken within young woodland. As it ran across the golf course it was easy to follow across the fairway, but the mound has been flattened by landscaping (Figure 8), or in some cases, used as a feature within the course.

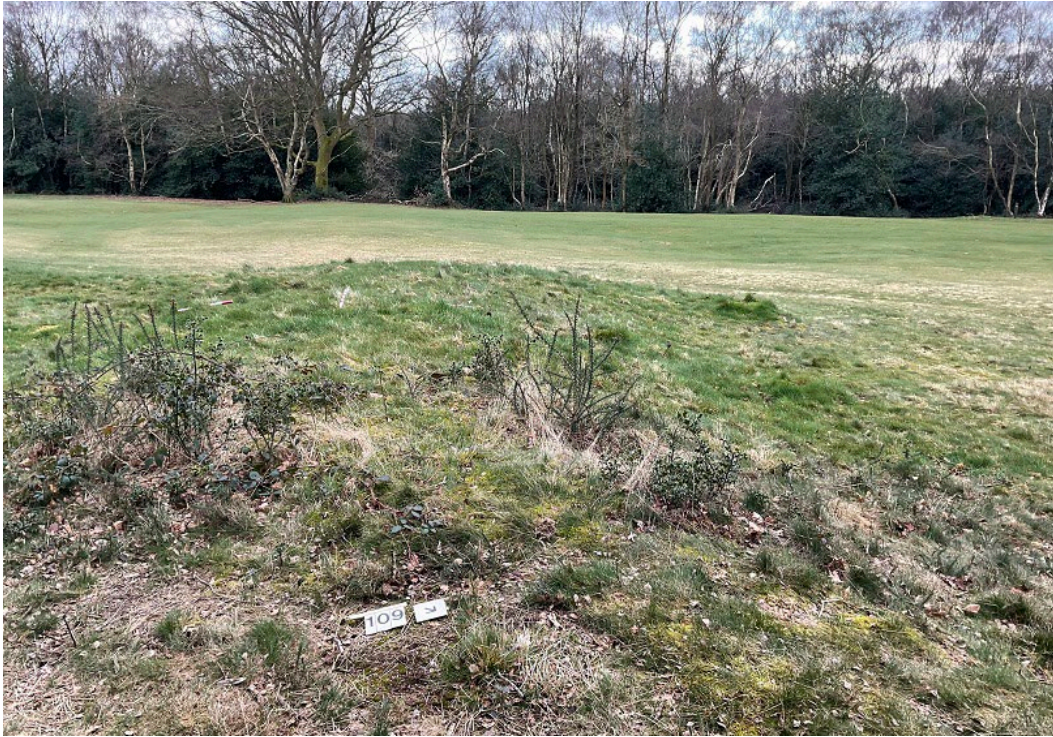
Figure 9: An artificially raised section of agger at the edge of the fairway, looking south-west (Photo 377, Feature Observation 109)

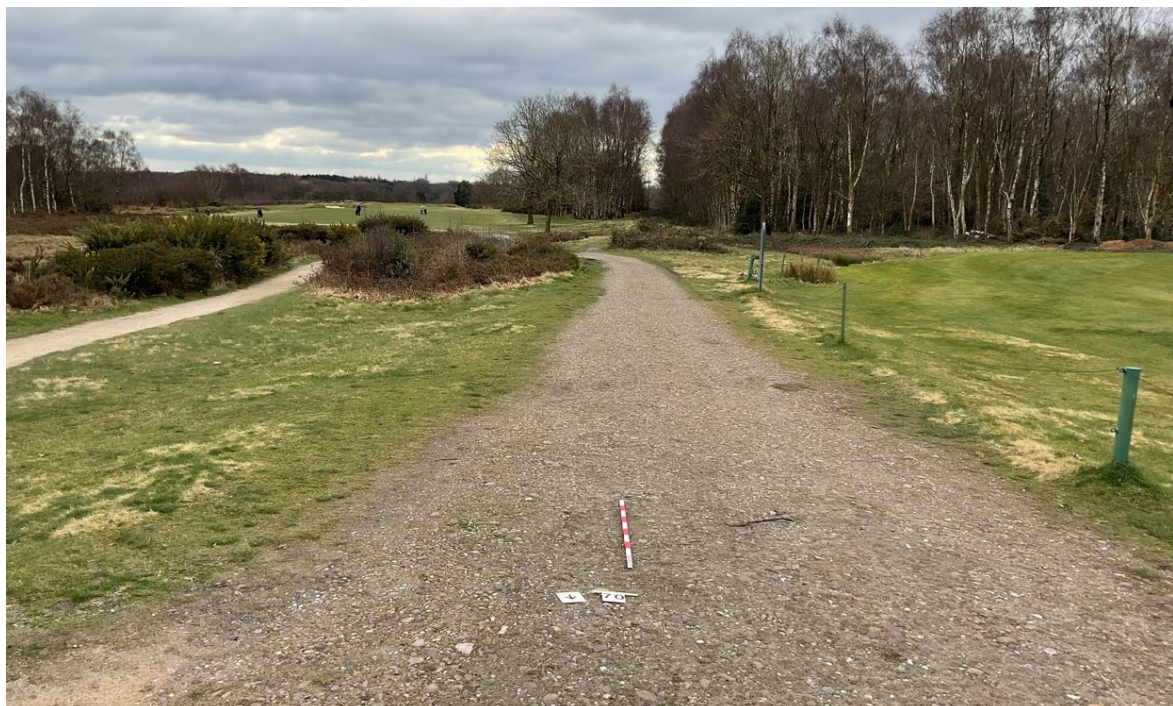
Feature Observation 70, Exposed Agger within Golf course, looking south. Photo 245.

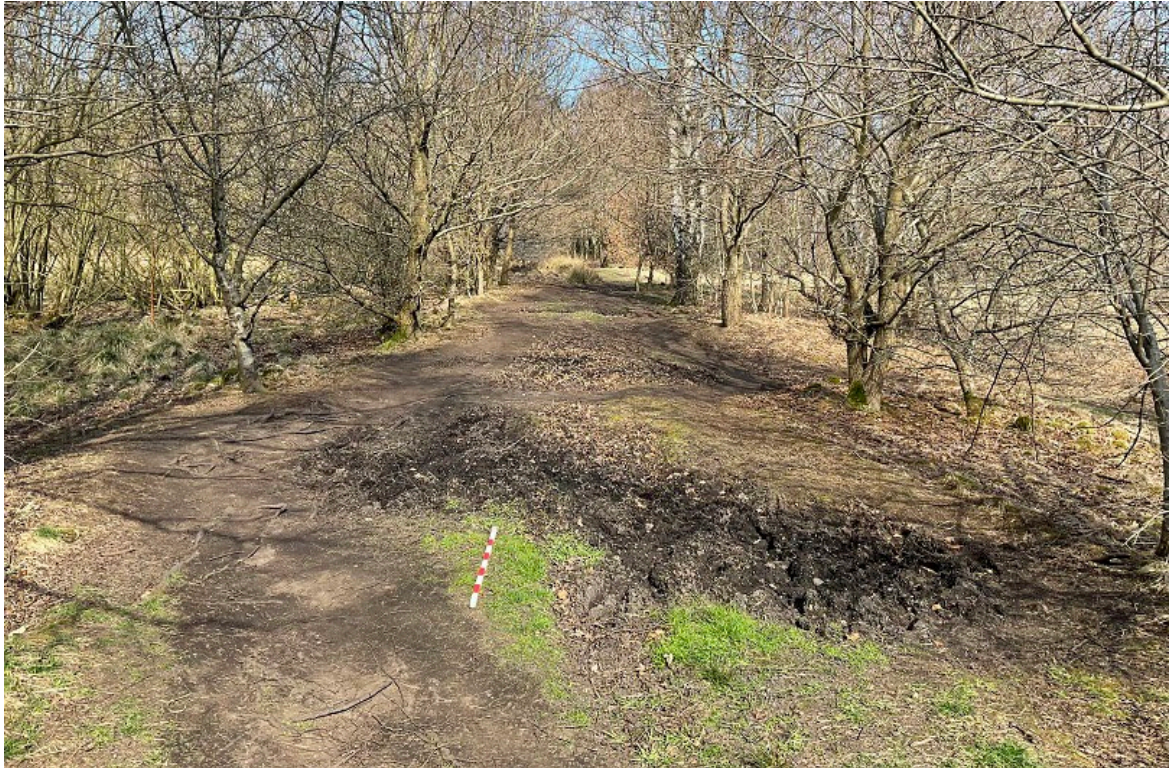
Figure 10: The aggrer as a footpath at the northern end of the park (Photo 474, Feature Observation 167)

To the north of the railway line, where the land was more heathland and woodland, it became easier to identify again and was used as a footpath again for most of this section (Figure 10).

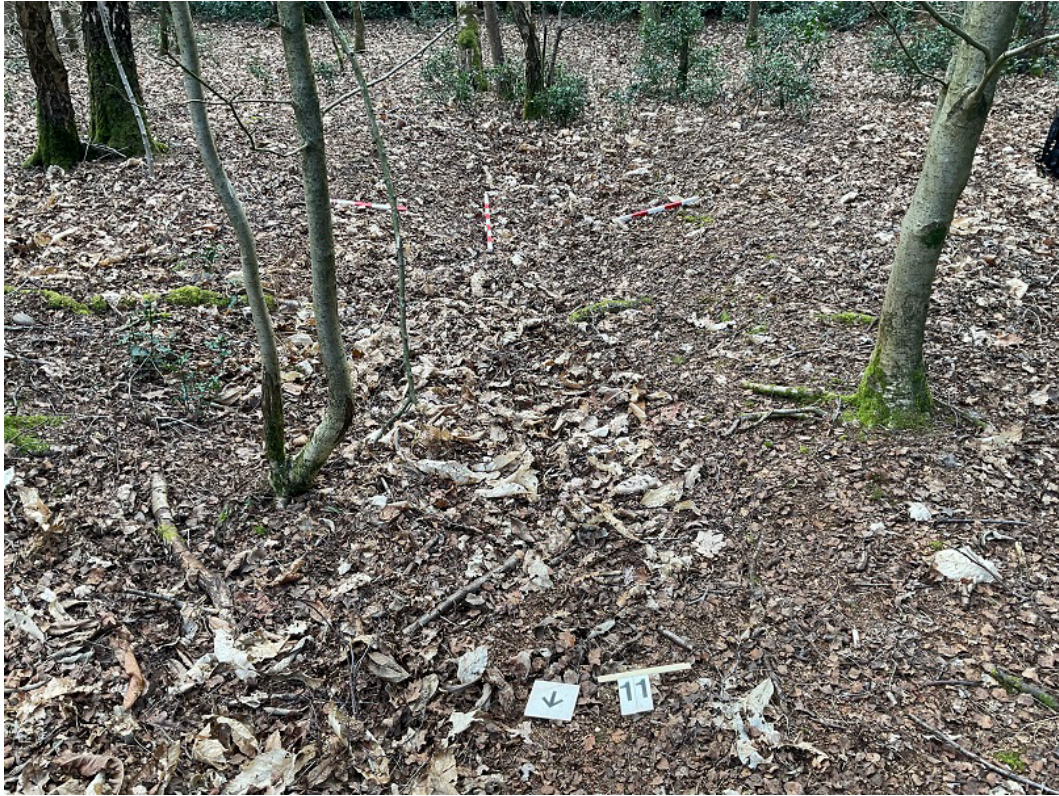
Figure 11: Roadside ditch in southern wooded area, looking south (Photo 16. Feature Observation 11)

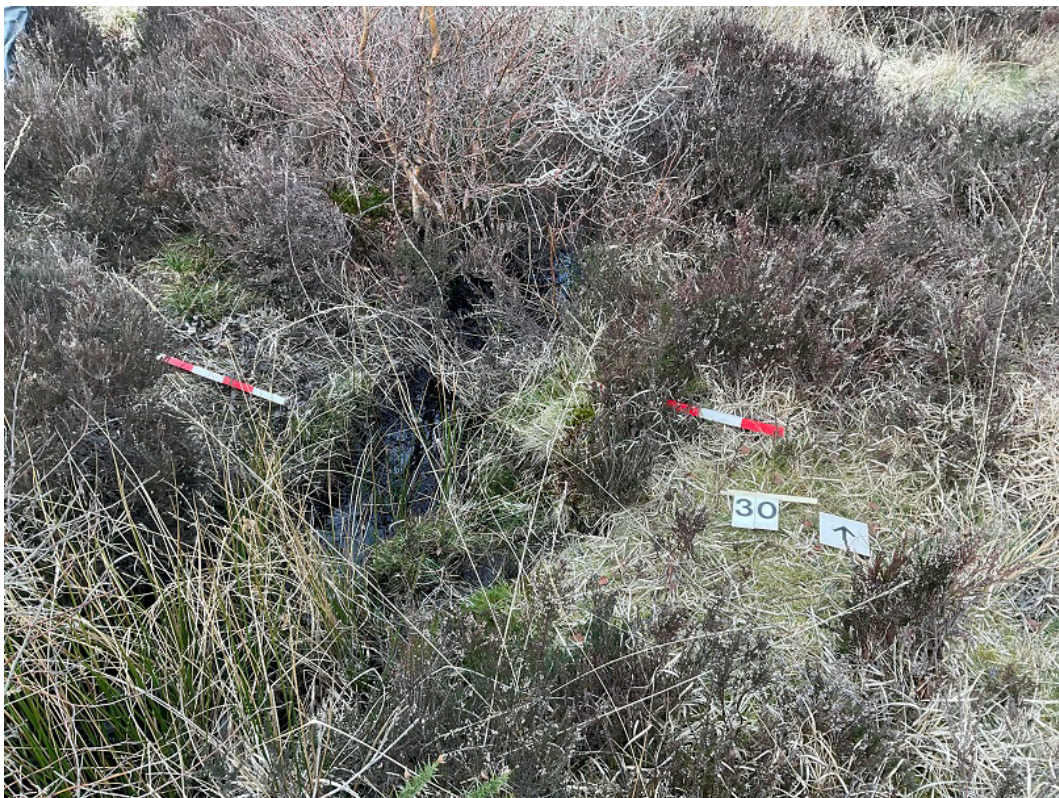
Figure 12: Water within roadside ditch in heathland area, looking north (Photo 125, Feature Observation 30)

As in the case of the aggrer, the narrow ditches each side of the aggrer mound, varied in their visibility and form depending on the landscape. At the south-western end of the park, within the wooded area the ditches were often shallow and full of leaves, which made them difficult to identify (Figure 11), whereas across the heathland they were often around 0.20m to 0.30m deep and full of water (Figure 12).

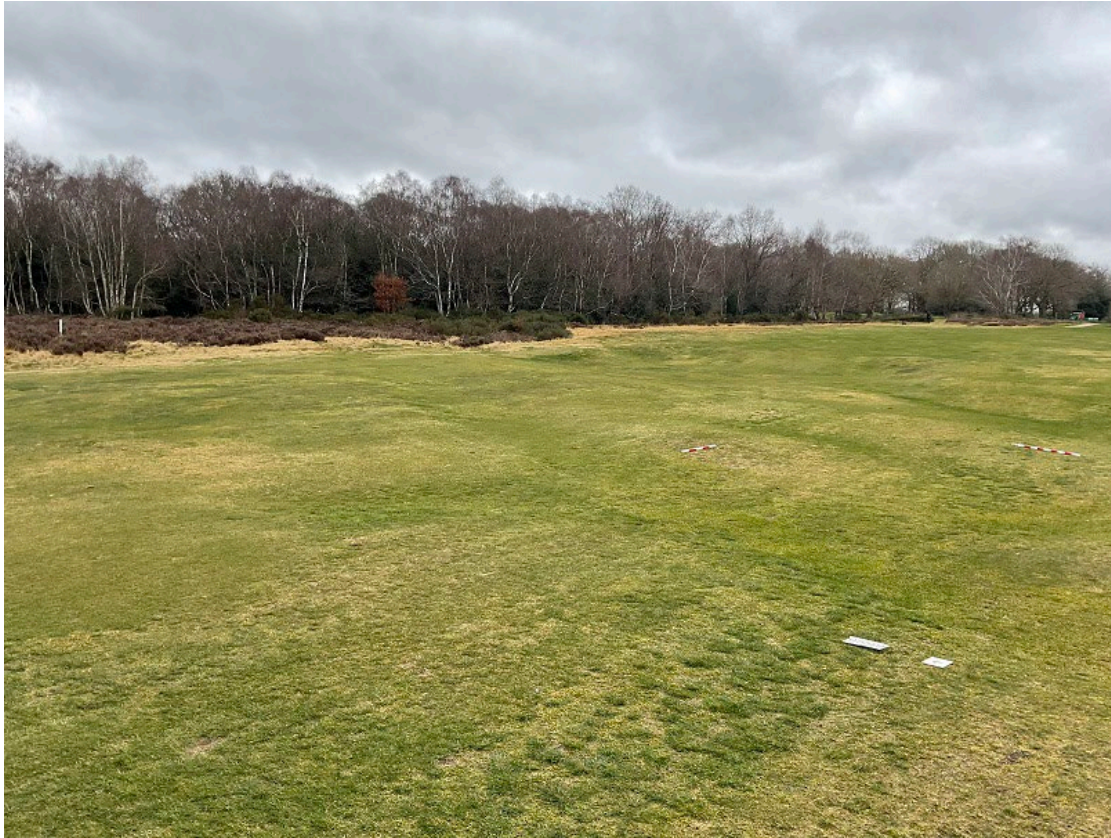
Figure 13: Ditches as shallow depressions each side of the agger within golf course, looking north-east (Photo 324. Feature Observation 95, 99)

Across the golf course they were discernible each side of the flattened aggrer as a low narrow depression (Figure 13), but very difficult to identify within Streetly Wood. To the north they were often vague but fairly identifiable despite often being full of leaves or vegetation (Figure 15).

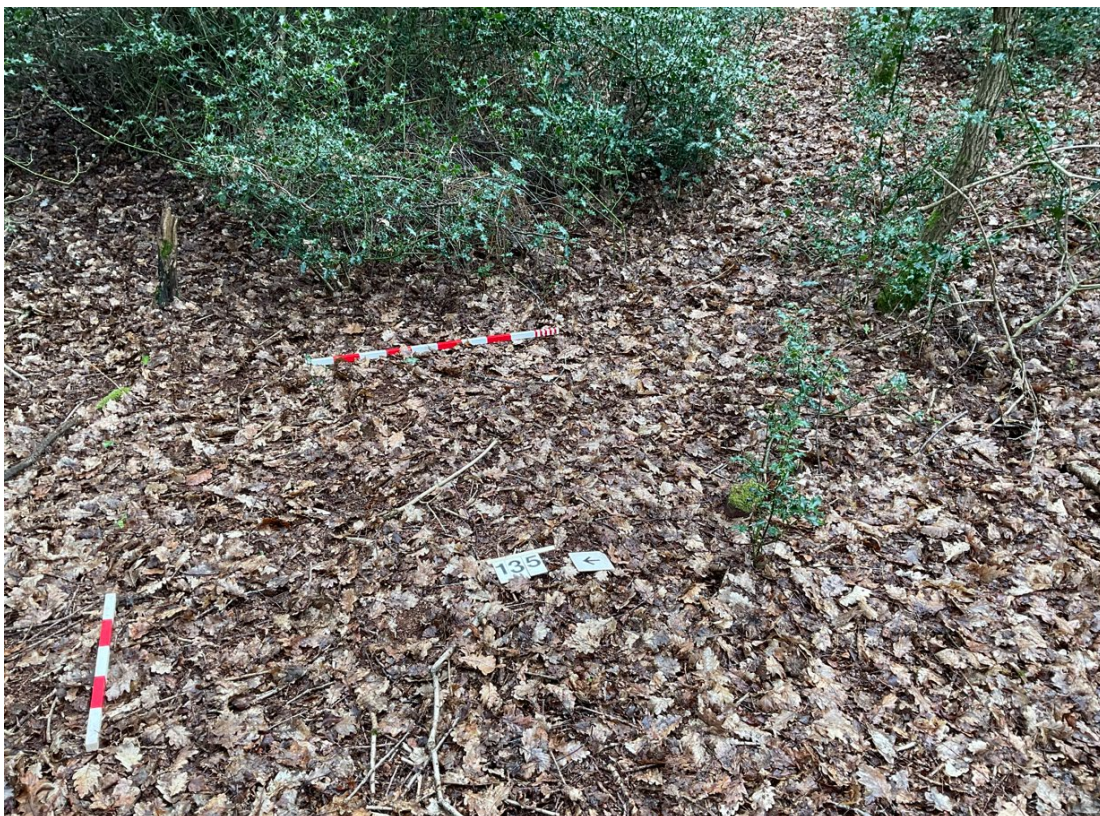
Figure 14: Roadside ditch surviving on west side of Agger within Streetly Wood (Photo 353, Feature Observation 135)

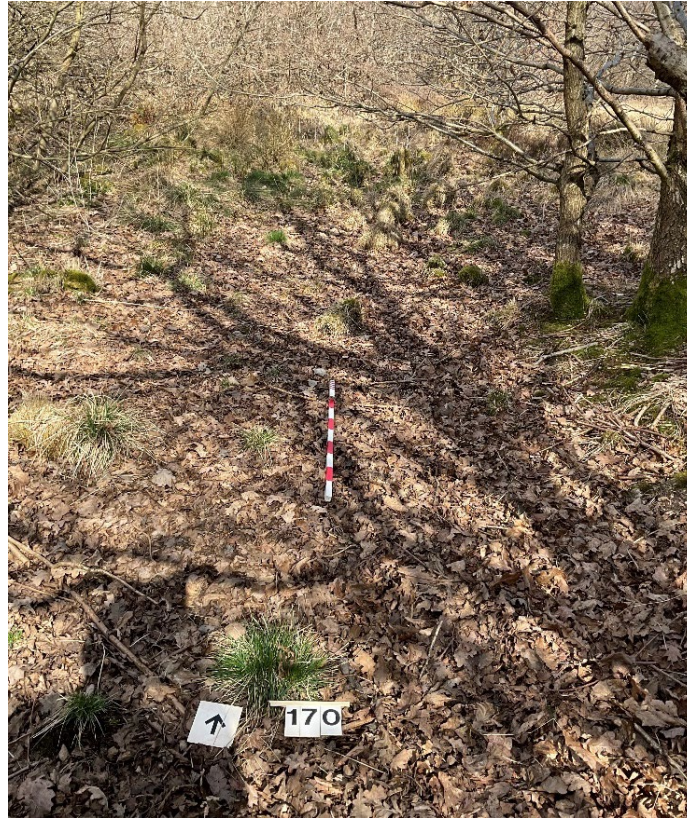
Figure 15: Leaf-filled narrow roadside ditch in northern area, looking north (Photo 479, Feature Observation 170)

Most were filled with leaves or vegetation or had trees growing out of them and were generally difficult to discern without the use of the GPS or iPad (Figure 15).

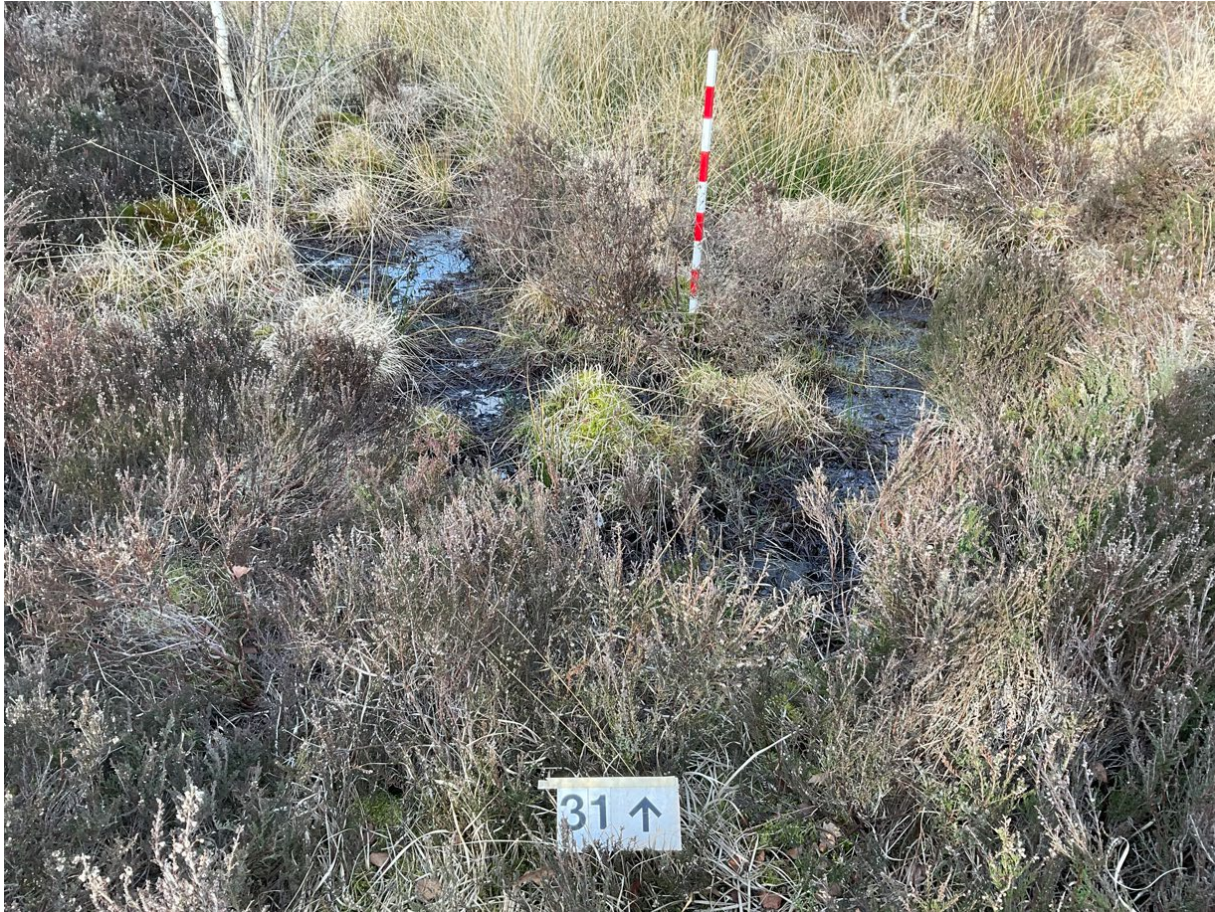
Figure 16: Feature Observation 31, Photo 131. Water filled pit feature, adjacent to road, looking north.

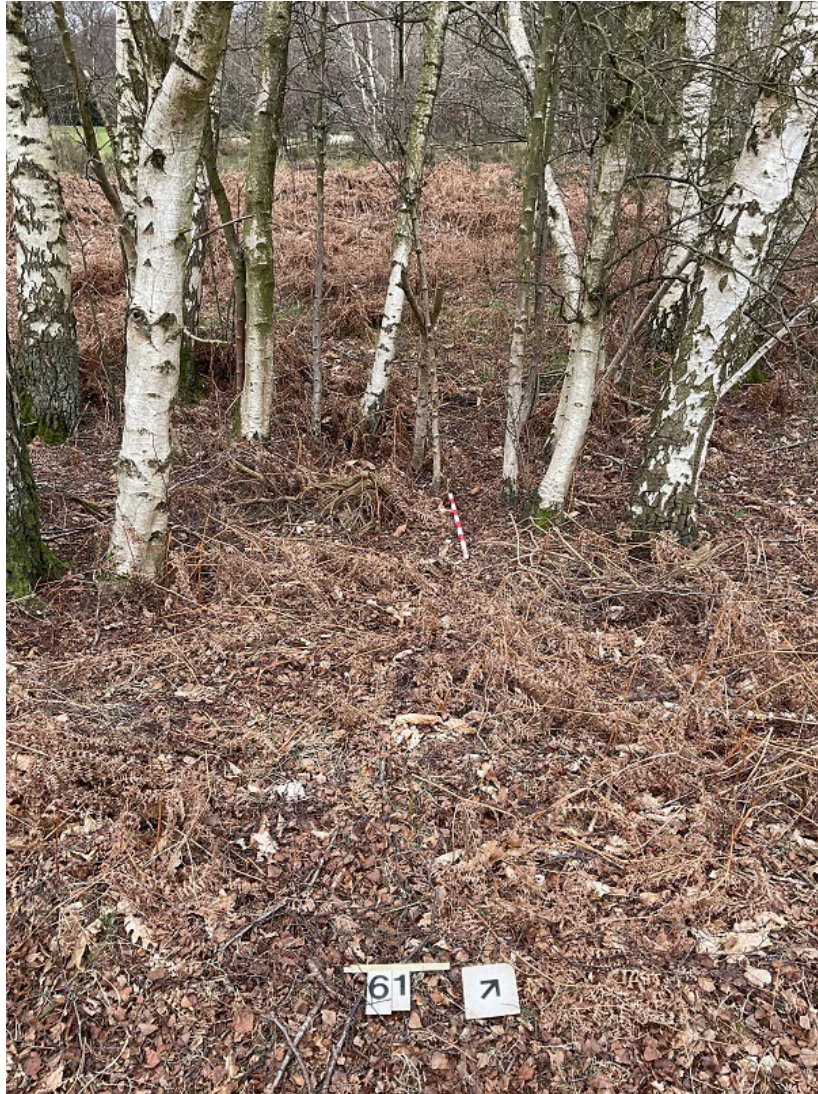
Figure 17: Trees growing out of quarry pit in woodland at southern edge of golf course, looking north-west (Photo 212, Feature Observation 61)

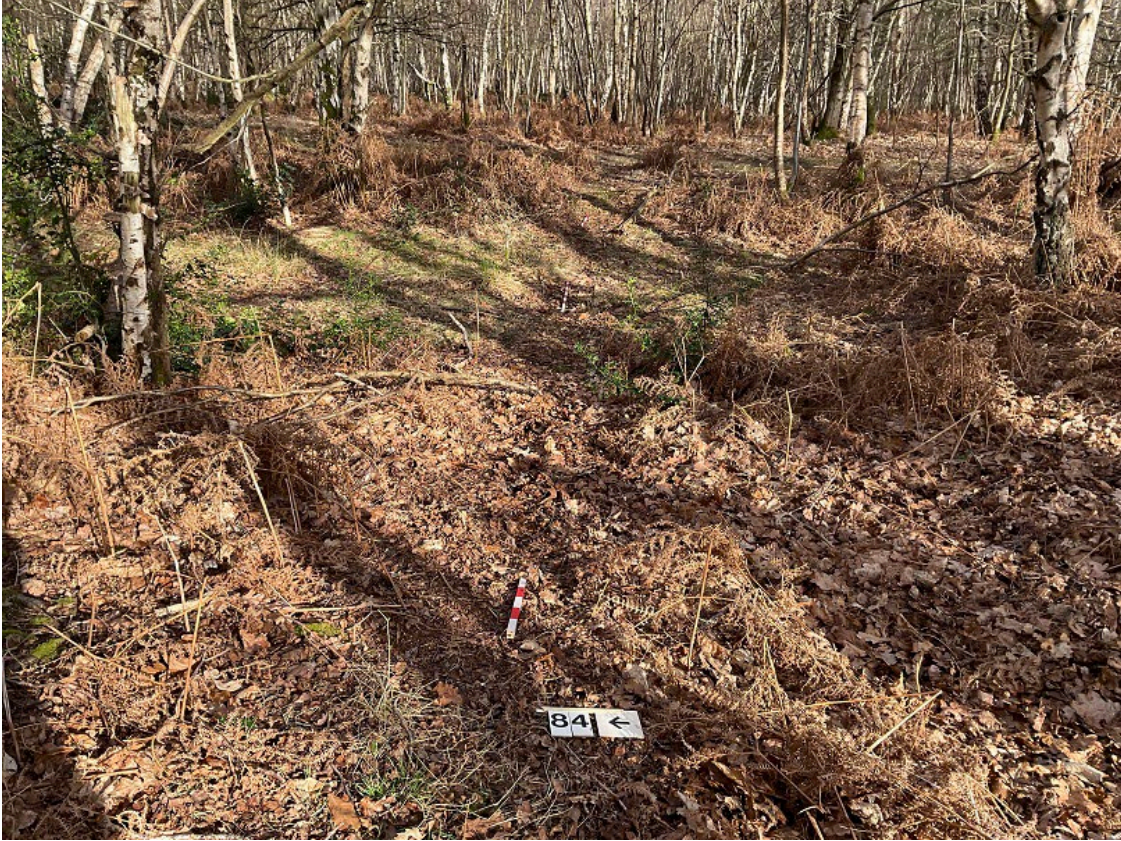
Figure 18: Large quarry pit, possibly an agglomeration of five or so pits in woodland close to feature MBM2499; MBM2590, looking east (Photo 290, Feature Observation 84)

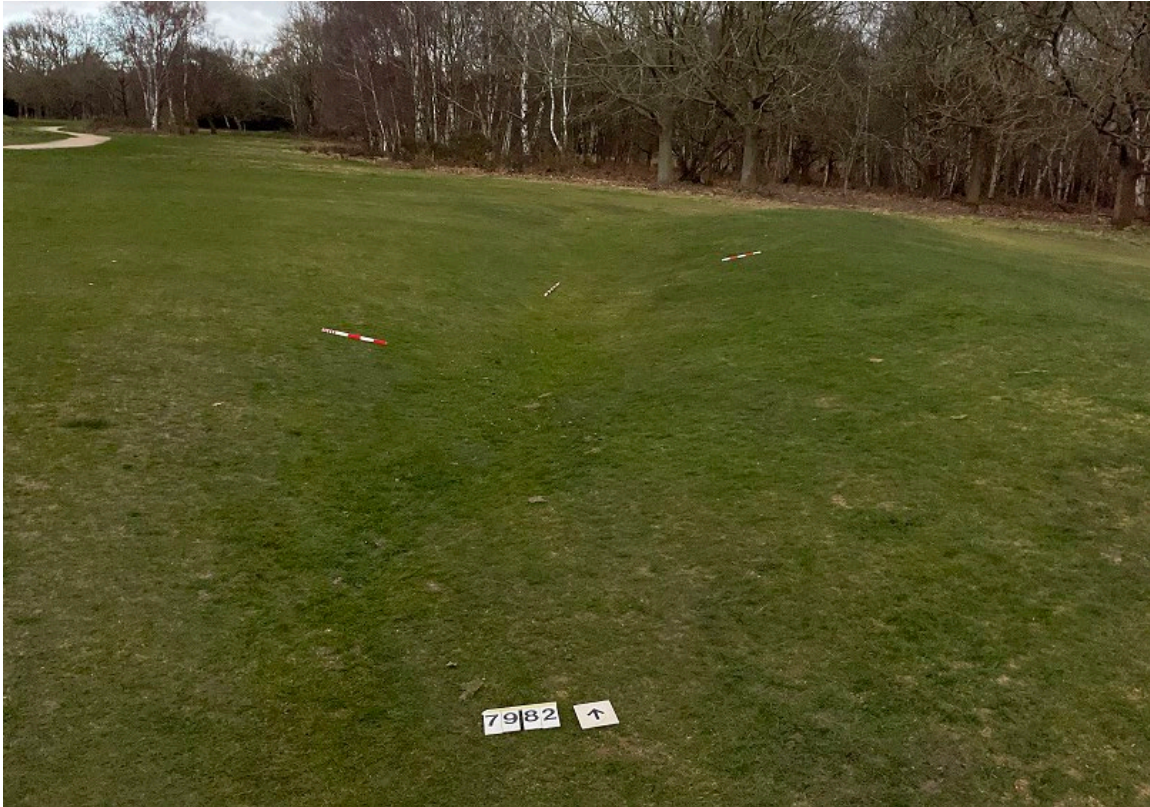
Figure 19: C-shaped mound and at edge of golf course, looking north (Photo 278, Feature Observations 79, 82)

Among the features investigated during the ground survey was a group of features that have been interpreted as a possible structure (Feature observation 79-82). This feature has been previously noted as an earthwork (Hodder 2013 p78) and is recorded on the Historic Environment Record (HER) for Birmingham as a mound or earthwork (HER Ref **MBM2499**) with a smooth bank forming what could be half of a square or rectangle with rounded corners (**MBM2590**). Part of this feature was seen as a C-shaped bank around 28m long, in a well-tended area of the golf course close to a small wooded area. Opposite this, partly within the woodland was another, less defined, C-shaped bank facing the first. Both sections of the feature seem to respect the line of the Roman agger, which lies around 18m to the east (Figure 20).

A sub-rectangular structure was recorded at NGR 408582 297492, Feature Observation 79-82. The feature, recorded on the HER (**MBM2499**) is located to the west of the Roman road and its orientation respects its alignment of the road. The structure comprises two ditches and a low micro-topographic bank that are located approximately 18 m west of the road. A pathway appears to extend from the possible structure towards the north by east, parallel to the road, for c. 105 m. It is suggested that this might represent a structure contemporary with the use of the road (Williams 2025 p30). However, a report on the excavation of part of the feature in 2021 concluded that the feature was not Roman and was most likely 19<sup>th</sup> or 20<sup>th</sup> Century in date (White et al 2021, p19).

In the context of known golf course redesign, and the documented lengthening of holes and probable creation of redundant golf course features as part of this process, **MBM2499** may well represent such a feature.

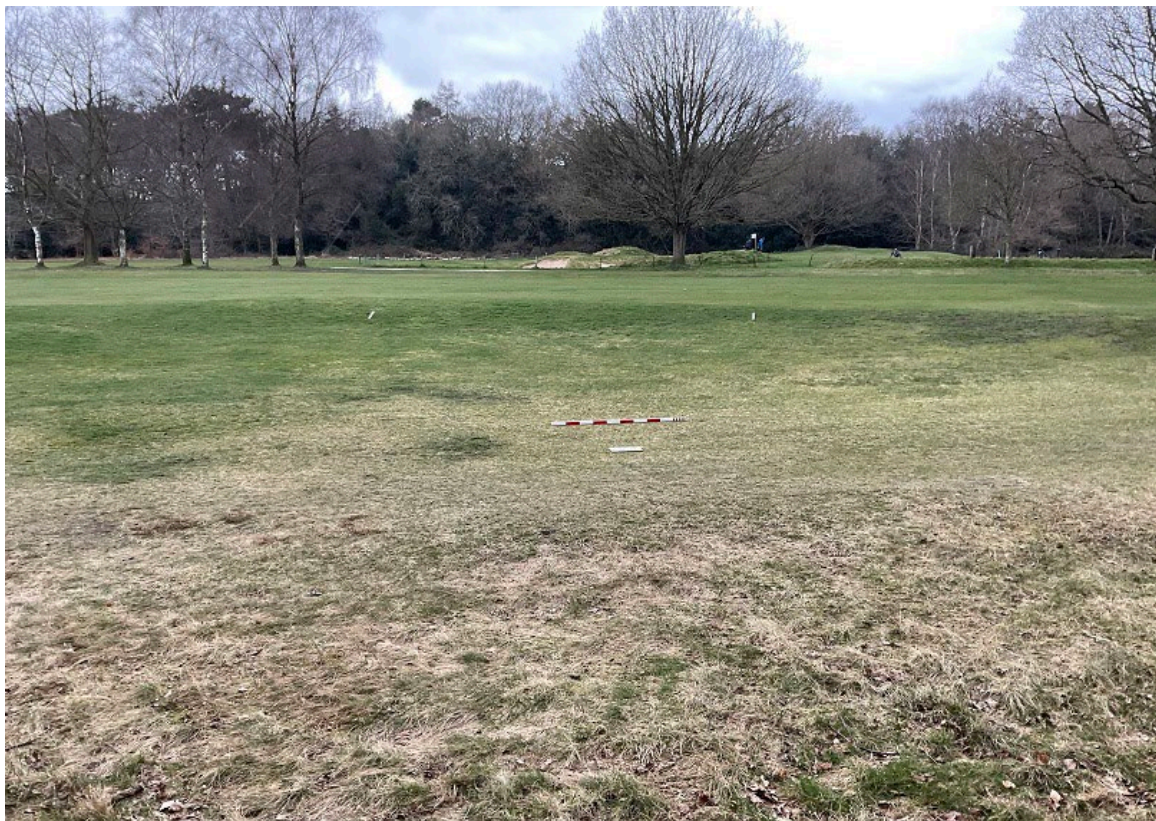
Figure 20: The C-shaped mound from the woodland, looking west across to the golf course (Photo 282, Feature Observations 79, 82)

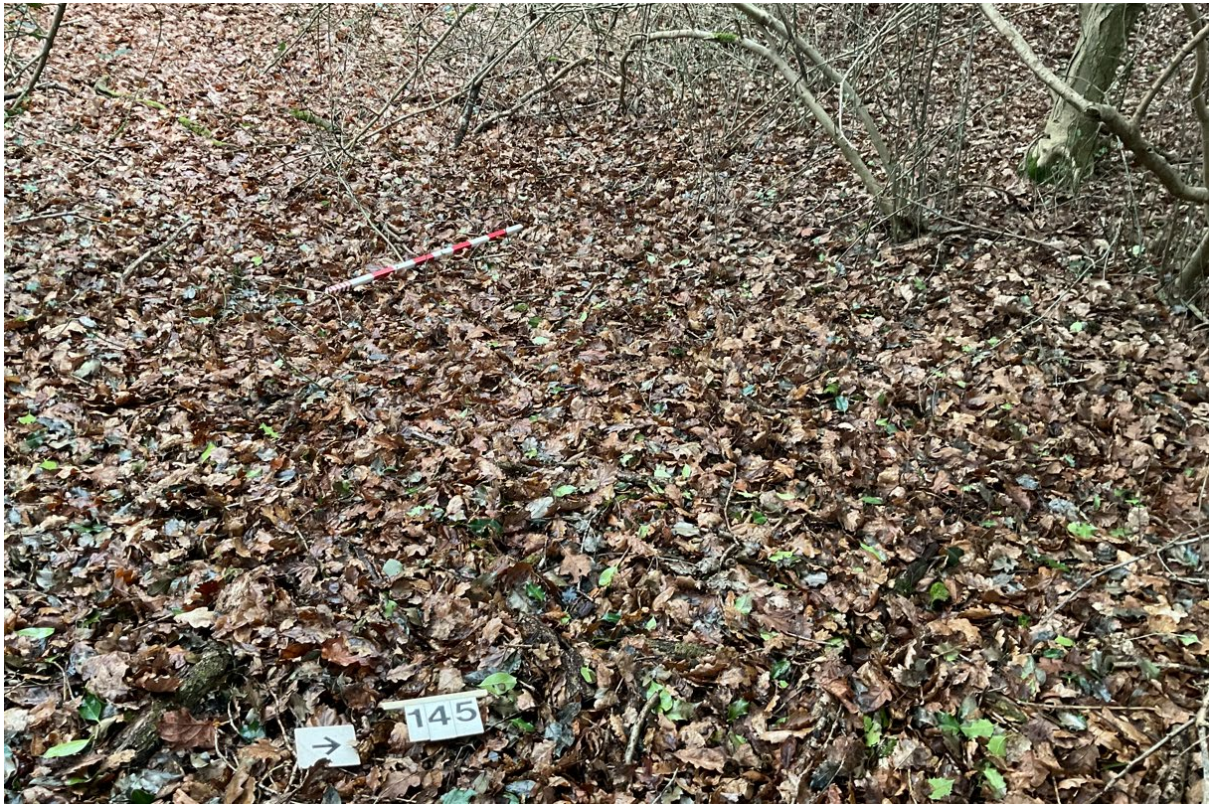
Figure 21: Feature 145, Photo 407, looking west. A wide depression survives an infilled pit. This might stem from quarrying for the road construction, or possibly be an infilled saw pit.

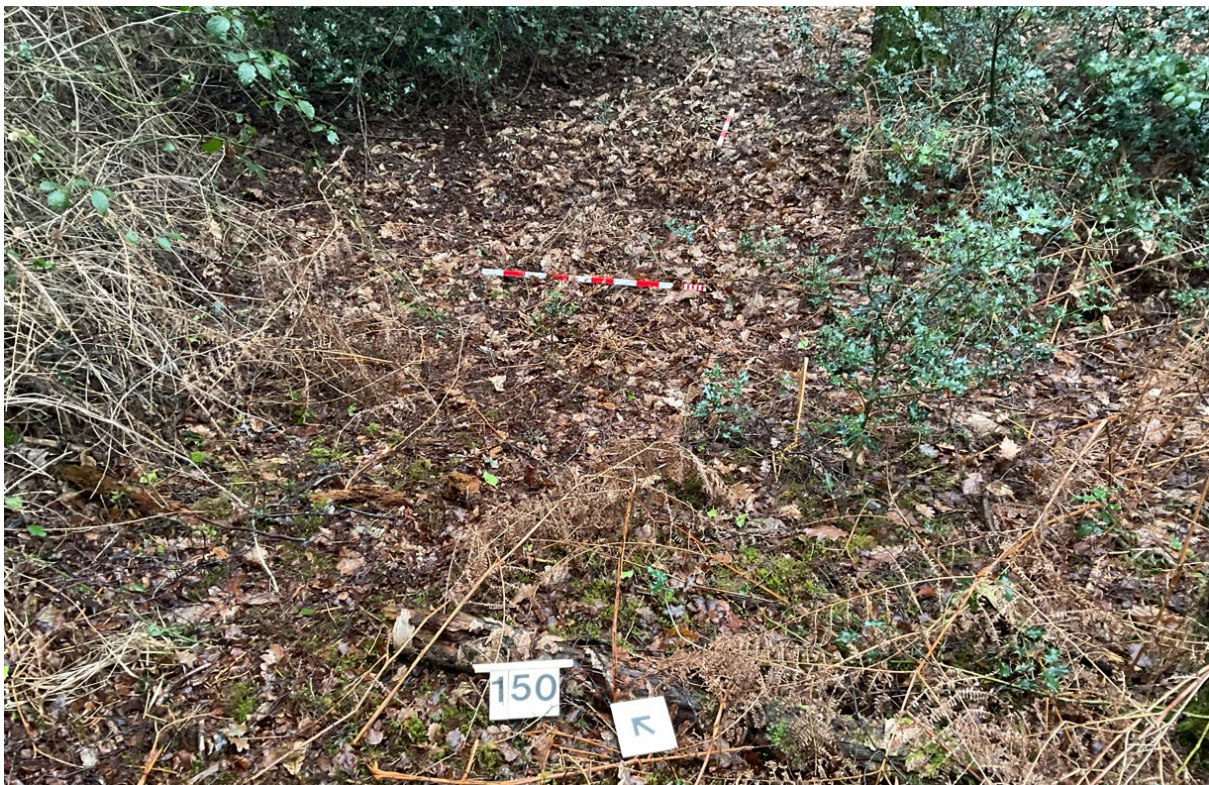
Figure 22: Feature Observation 150, Photo 410. A well-defined pit type depression to the north of the intersection between Rykniel Street and Streetly Wood boundary.

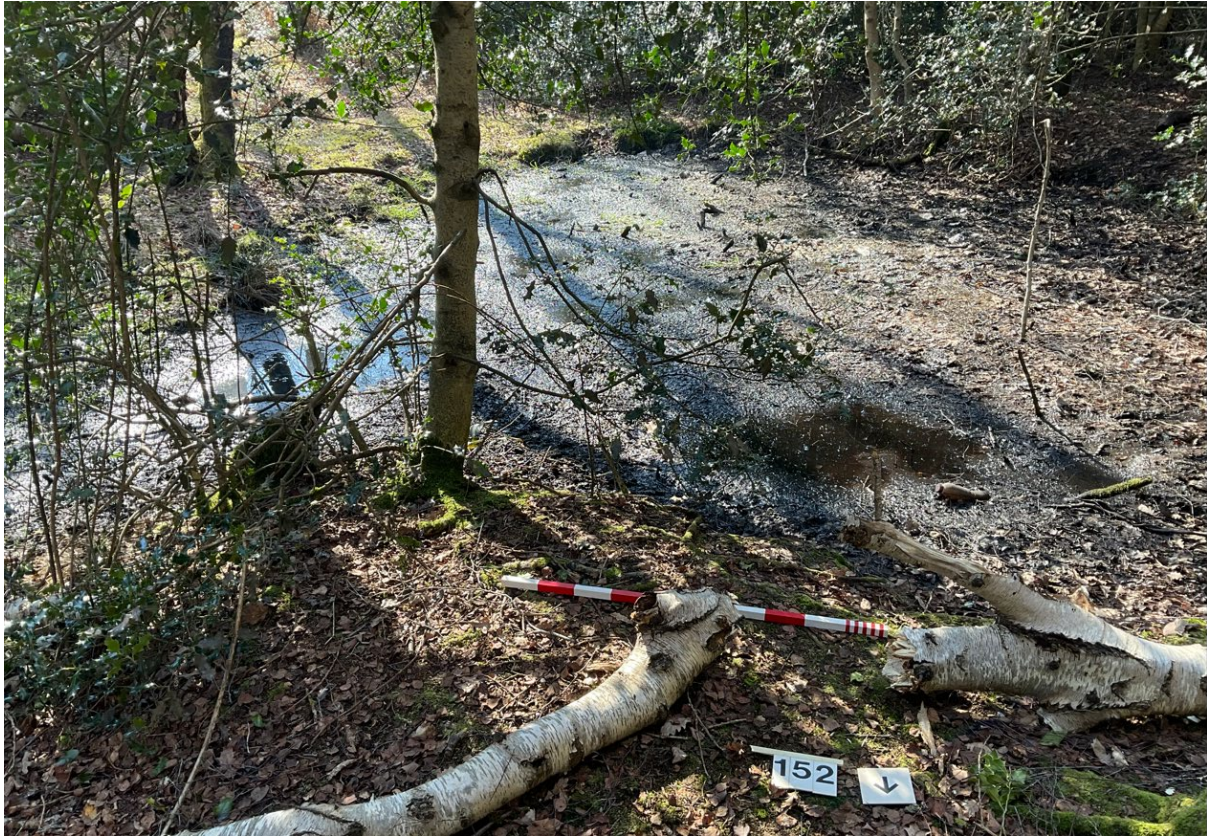
Figure 23: Feature Observation 152, Photo 419, looking south. A substantial water filled depression.

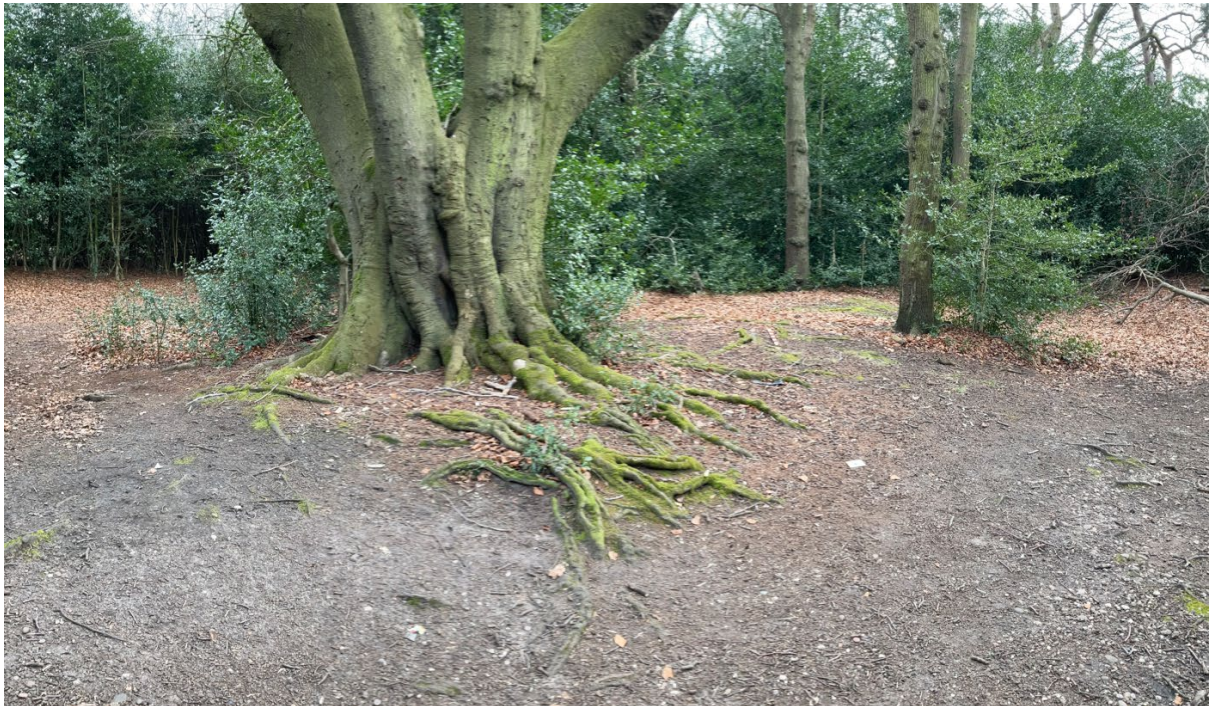
Figure 26: Feature Observation 1, Photo 510 Wood bank (HER MBM2447)

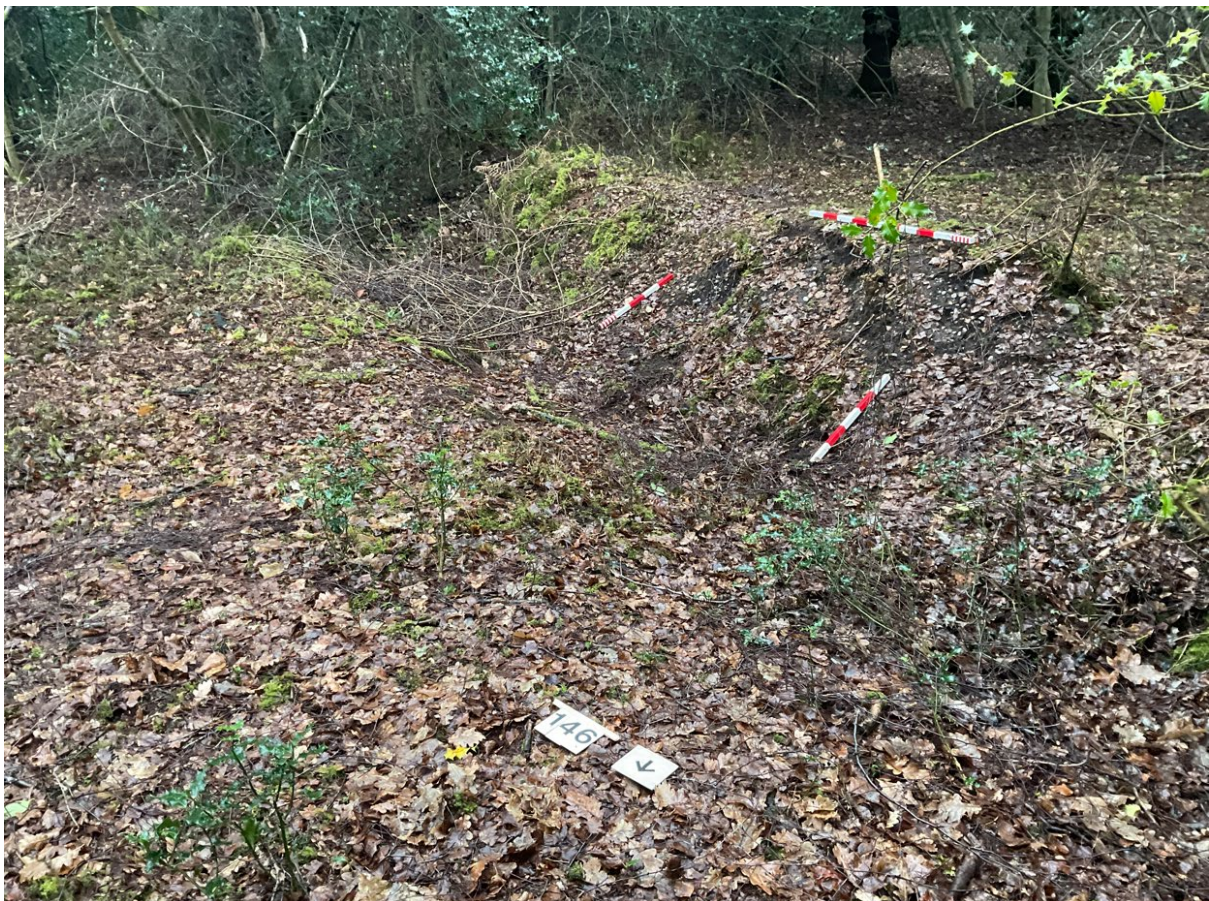
Figure 27: Feature Observation 146, Photo 414. The bank and ditch of Streetly Wood.

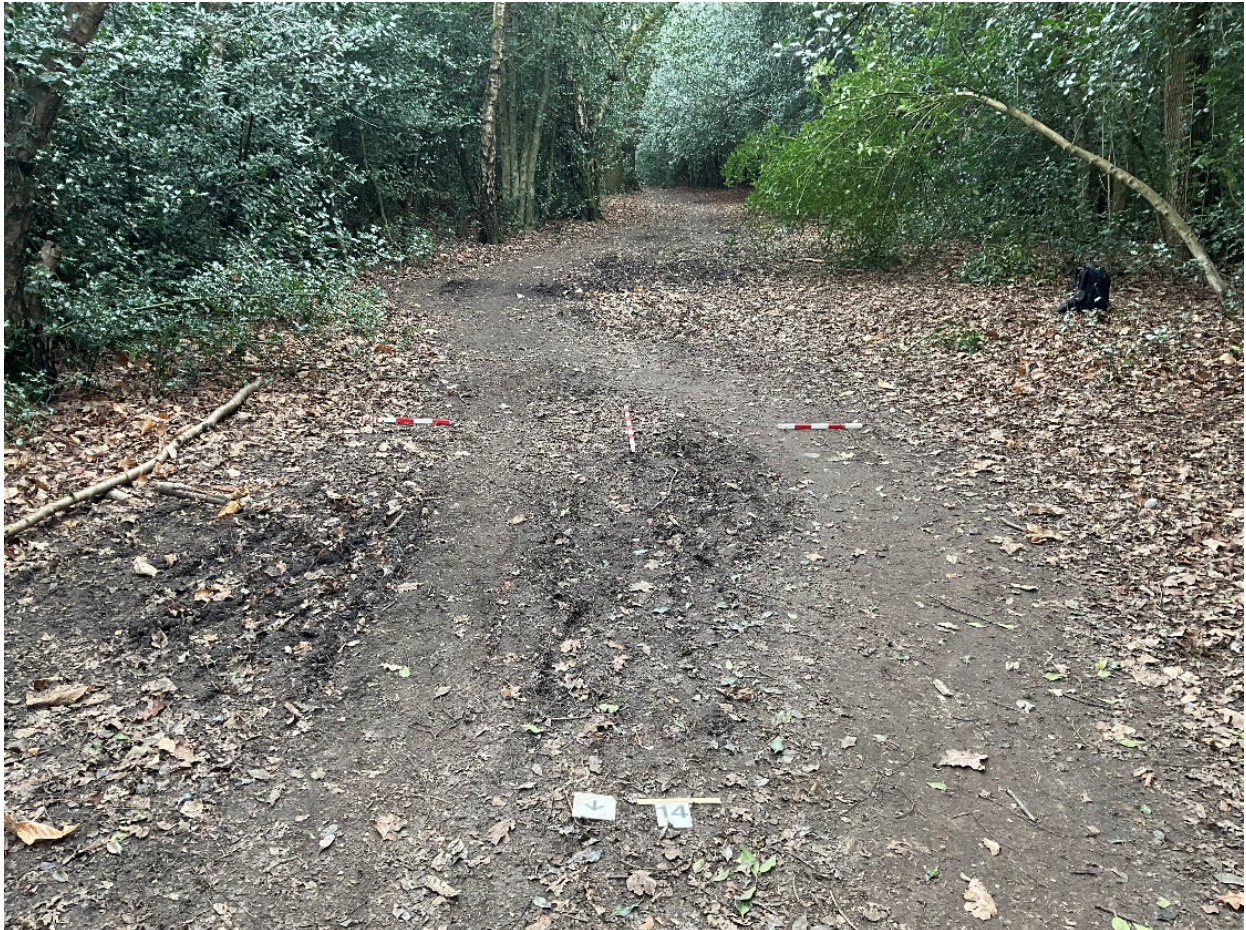
Figure 28: Feature Observation 14, Photo 32, looking south – Cycles and pedestrians
