An Archaeological Walkover Survey at Sutton Park NNR,  
Royal Sutton Coldfield, Birmingham, West Midlands.  
SP 08600 97200 (centre)

ULAS Report No. 2025-030  
© ULAS 2025

# **An Archaeological Ground Survey at Sutton Park NNR, Royal Sutton Coldfield, Birmingham, West Midlands**

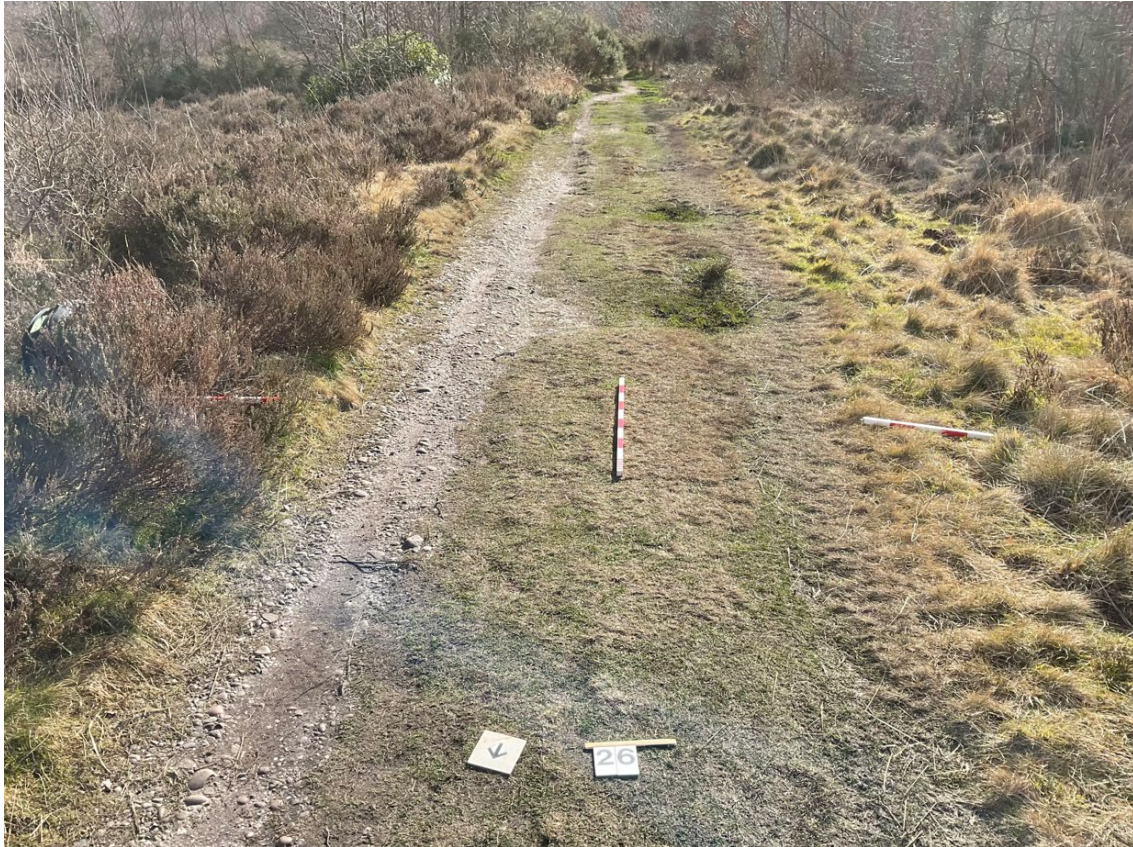
Figure 31: Feature Observation 26, Photo 107, looking south, showing Length of agger – erosion of metaling

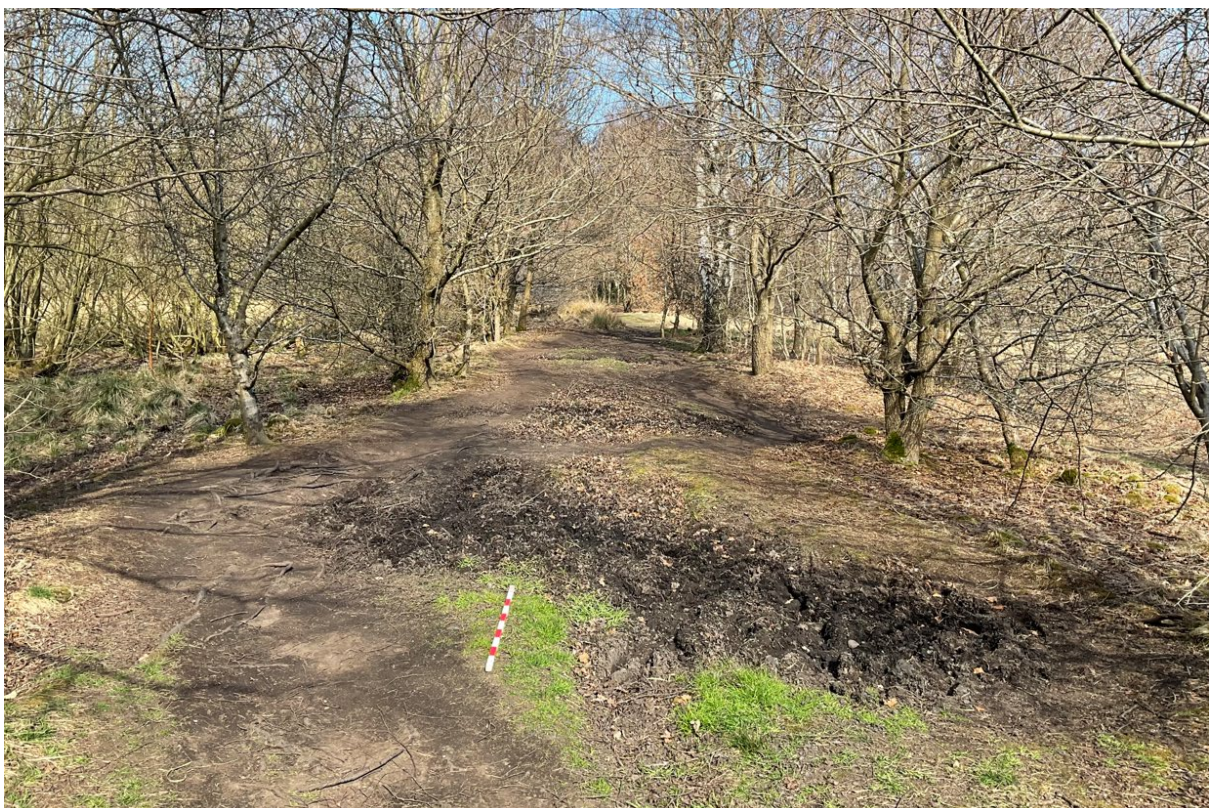
Figure 34: Feature Observation 167, Photo 475. Agger exposed by path erosion to the north of the railway

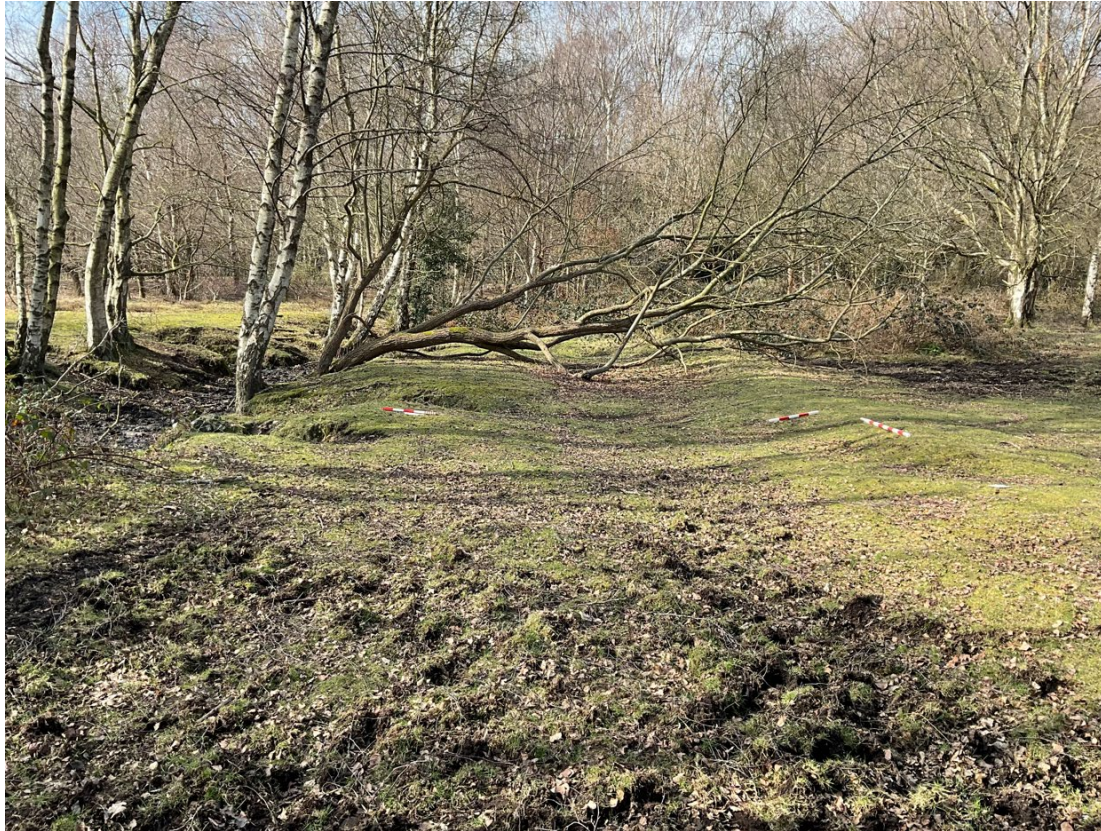
Figure 35: Feature Observation 177, Photo 504, Some poaching of the ground by ponies in a boggy area.

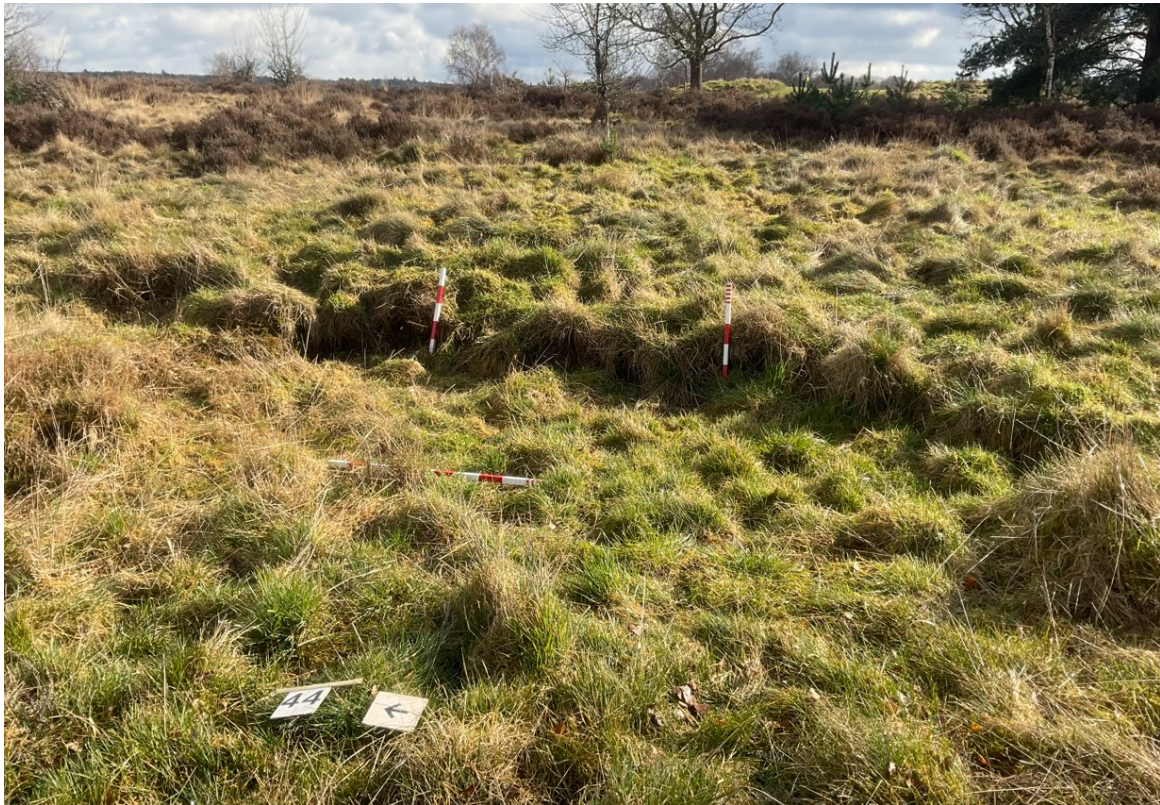
Figure 37: Feature Observation 44, Photo 164 looking east. The changes in the surface here may be due to old badger setts

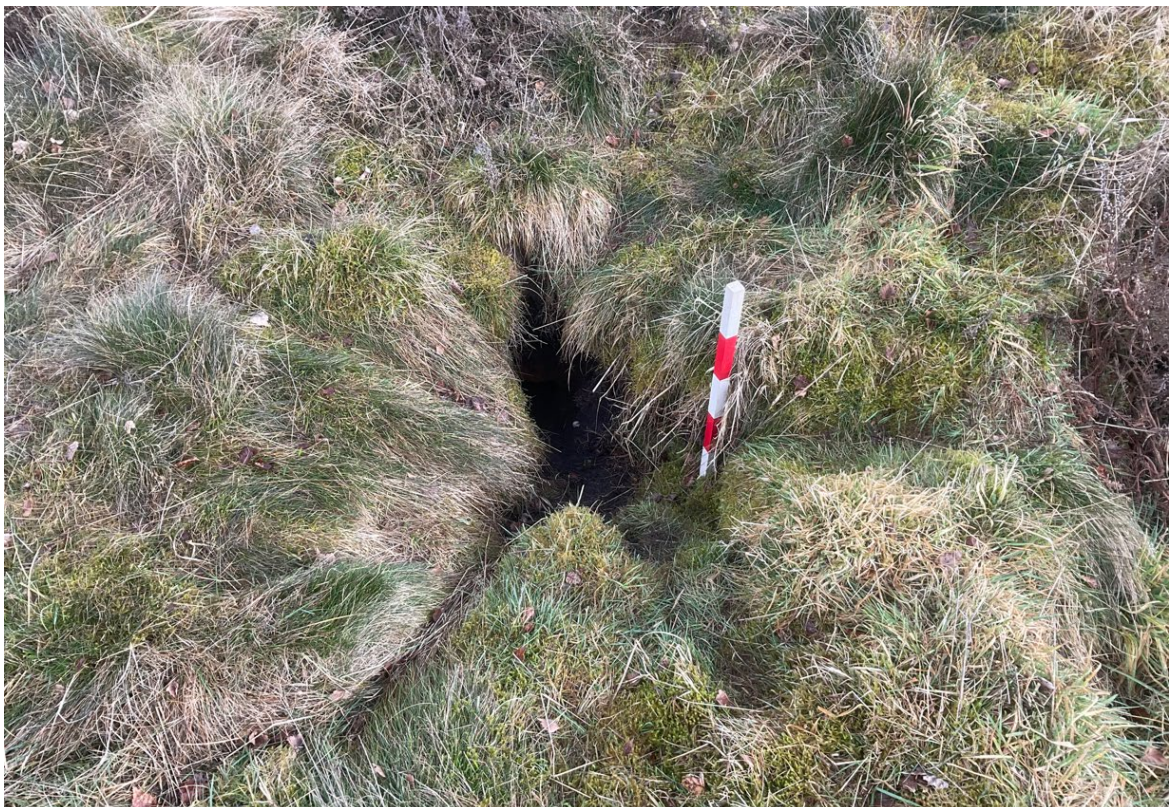
Figure 38: Feature Observation 46, Photo 170, possible badger sett

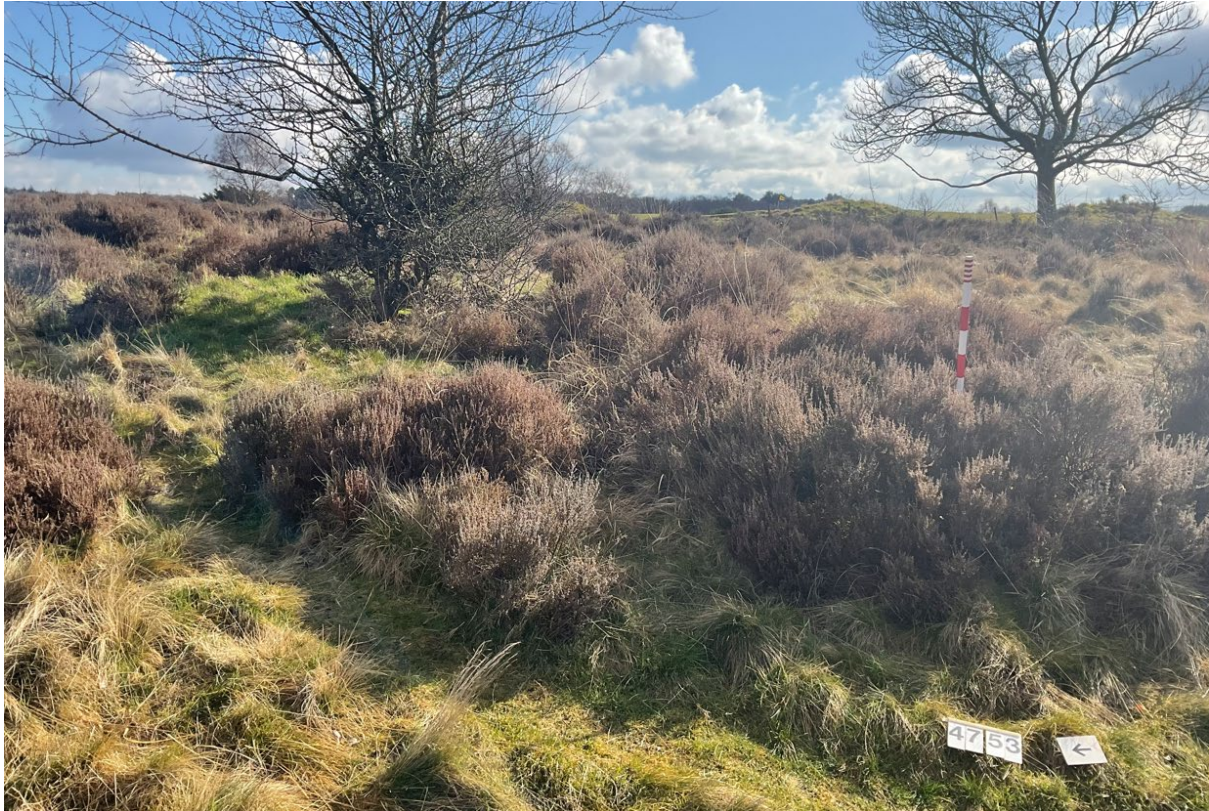
Figure 39: Feature Observations 47-53. Tussocky grass on irregular ground may have resulted from badger setts and is not convincingly archaeological in origin. Photo 175 looking east.
